Manhole Inspection Summary

Manhole # S07MM1028MH

Location Address: **3611 SPAULDING AVE**

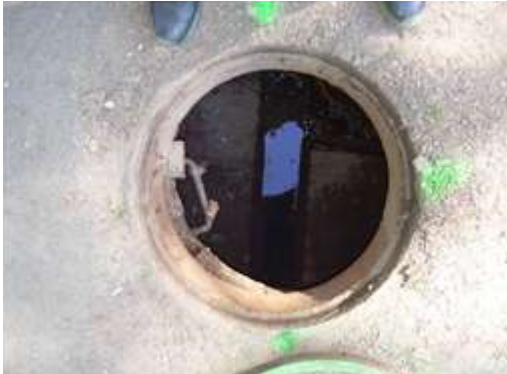
Top View

Frame Offset: **1** (in.) Condition: ☒ Sound ☐ Cracked ☐ Leaks

FRAME OFFSET

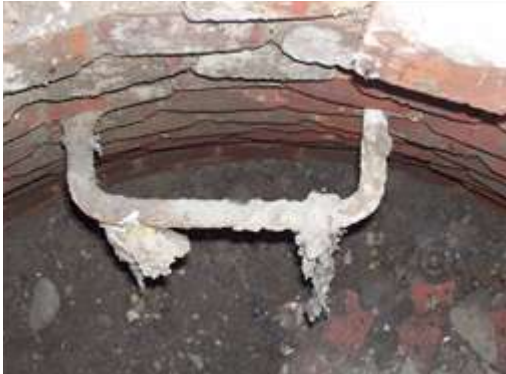
Defect 1

Surcharge ☒ **Evidence Of Surcharge** Depth: **1.5** (ft.) ☐ Active Surcharge Present

EVIDENCE OF SURCHARGE

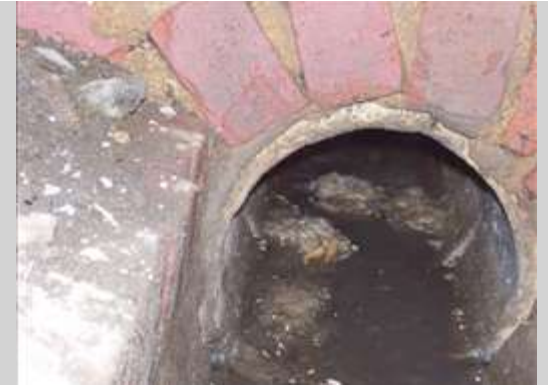
12 O'Clock Outflow

BENCH AND CHANNEL DEBRIS

Pipe Height: (in.) Direct
Pipe Material: **Clay** ☐ Pipe Lined
Invert Depth: **4.30** (ft.) Flow Characteristics: **Slow**
Deposits: ☐ None ☐ Mud ☐ Sludge ☒ **Debris** ☐ Grease
Silt Depth: **1.5** (in.) Deposits Extent: **Medium**
Infiltration: **None** Pipe Seal Cond: **Sound**

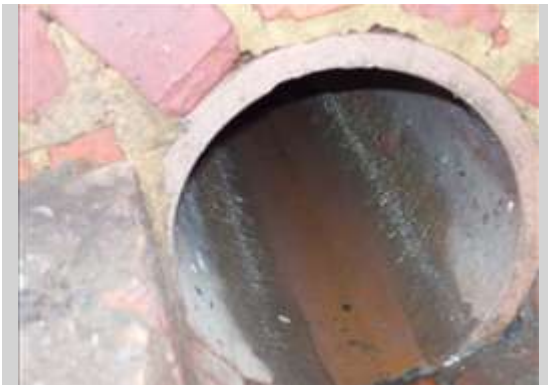
3 O'Clock Inflow

Pipe Height: (in.) Direct
Pipe Material: **Clay** ☐ Pipe Lined
Invert Depth: **4.27** (ft.) Flow Characteristics: **Slow**
Deposits: ☒ **None** ☐ Mud ☐ Sludge ☐ Debris ☐ Grease
Silt Depth: (in.) Deposits Extent:
Infiltration: **None** Pipe Seal Cond: **Sound**

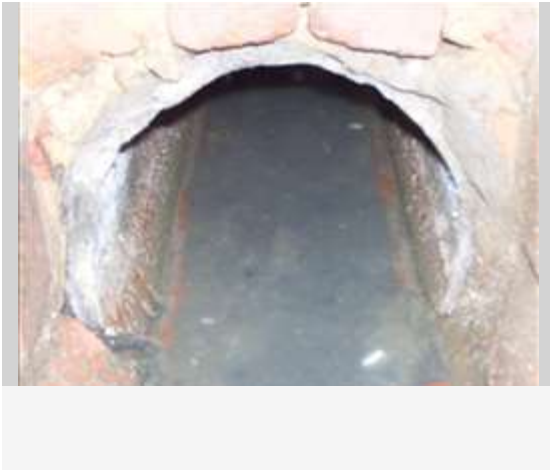
6 O'Clock Inflow

Deposits: ☒ None ☐ Mud ☐ Sludge ☐ Debris ☐ Grease

Infiltration: **None** Pipe Seal Cond: **Sound**
